# Magnetic Particle - MT Testreport

<b>Client:</b> Inspection of: VOLVO ECR 88 Order no xxxx	<b>Supervisor:</b> Drawing no.: N/A	<b>Test Site:</b> Project Name: Volvo ECR88	<b>Client Orderno.:</b> N/A Project No.: xxxx
---	--	---	---

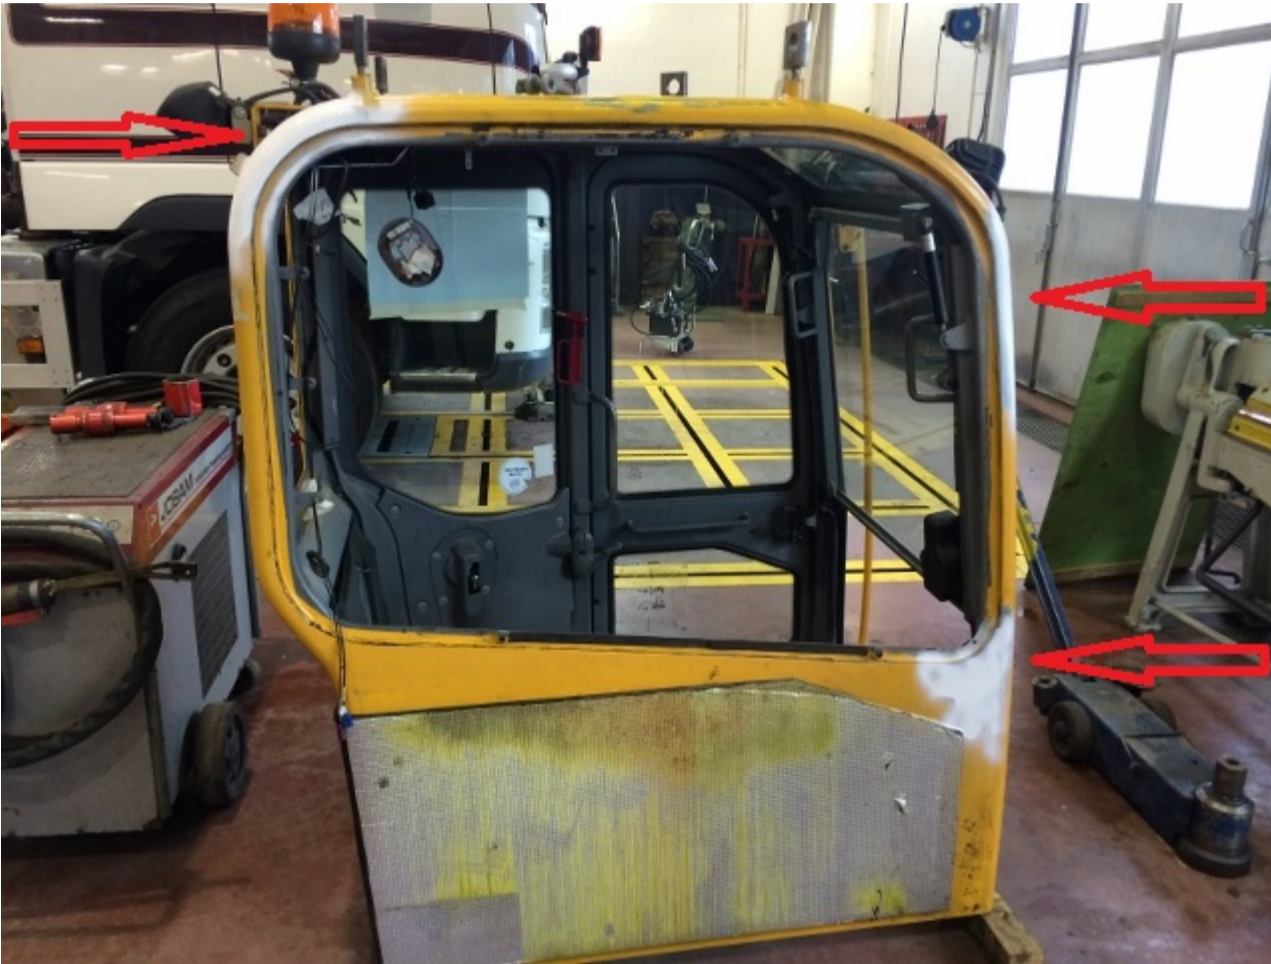
Pictures, drawing, sketches:

MT was performed on the straightening of diagonal side window. Rightside between A-stag and B-stag, and the straightening of dents on the roof right and front right. No relevant indications found.

**Accepted**
