Visual - VT Testreport

Client: Straumen Bil AS Inspection of: Volvo ECR88 Order no #0001:	Supervisor: NAVN Drawing no.: N/A	Test Site: xxxx Project Name: Volvo ECR88	Client Orderno.: N/A Project No.: Test 01A
---	---	---	---

Object / Geometry / Joint: Beam Weld Process: Not Stated Ref. Standard: NS-EN ISO 17637:2011	Dimensions (mm): 6 Surface Condition: Grinded Acc. Criterias: EN ISO 5817 Level B	Material: C/S Heat Treatment: No Post Weld HT Procedure: PRO TEST	Groove: N/A WPS: Not Stated Test Extent: 100%
--	---	---	---

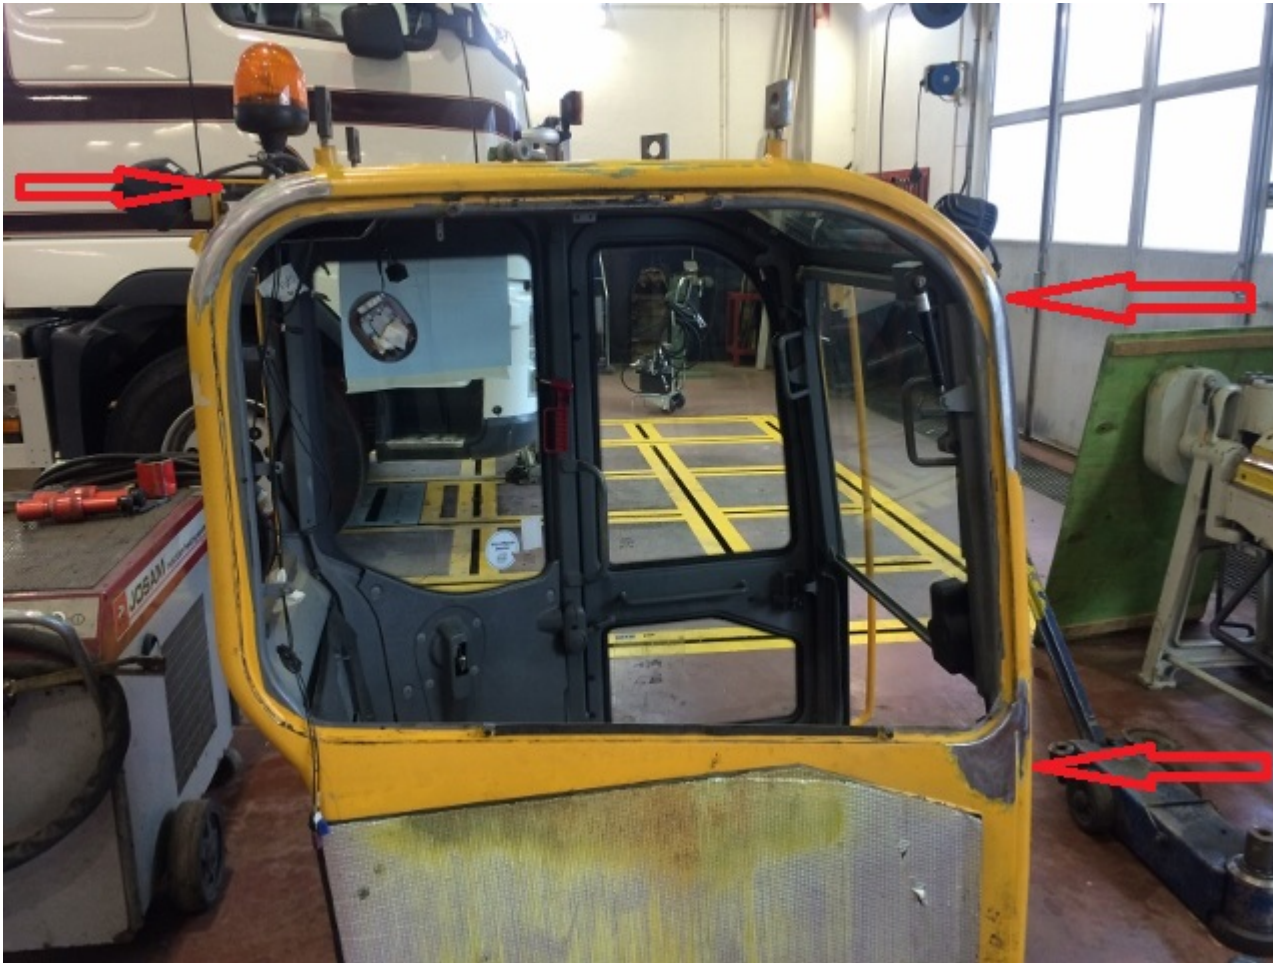
Pictures, drawing, sketches:

Comments, additional information:
VT was carried out on areas that have been straightened after damage.

Accepted
